Title: Results of International Space Station Vehicle Materials Exposed on MISSE-7B

Materials samples were exposed to the low Earth orbit (LEO) environment as part of the MISSE-7B flight experiment for 18 months. Optical properties, thickness/mass loss, surface elemental analysis, visual and microscopic analysis for surface change are some of the techniques employed in this investigation. Where possible, the MISSE-7B results are compared to analyses from other LEO experiments. ISS materials currently flying on MISSE-8 are also discussed.

*National Space & Missile Materials Symposium  
Tampa, Florida USA*

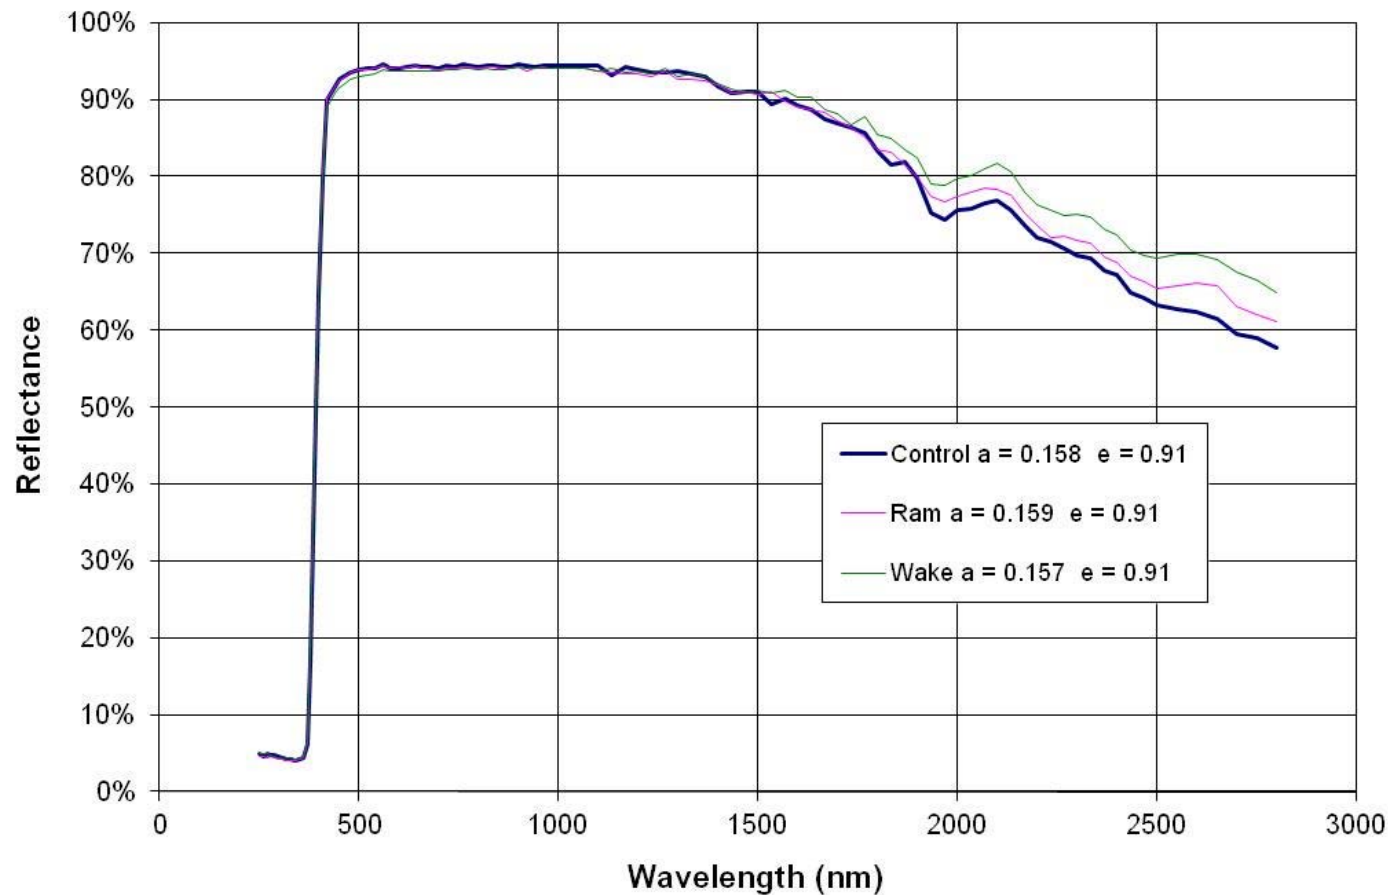
## MISSE-7B AZ93

- **AZ93 was flown as a bellwether for contamination and monitor for ISS radiator coating health.**
- **AZ400 is similar in performance to AZ93 but uses a low outgassing silicone binder.**
  - **Does not require controlled temperature and humidity when applying.**
- **AZ-2000-LSW and AZW/LAII – LSW are experimental organic versions of standard inorganic AZ-2000-IECW and AZW/LAII coatings, which have flown on previous MISSEs.**
- **RM-550-IB is known to be stable in UV, so was flown as a black backing for some of the carousel window samples.**
- **AZ3700 was developed specifically for  $\alpha$  and  $\epsilon$  close to 0.30 and as a protective/sacrificial film with 966 adhesive backing.**

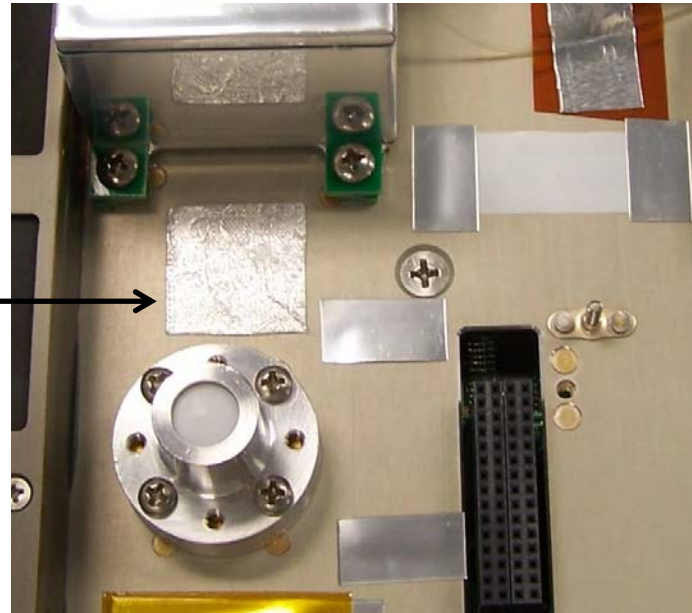
- AZ Technology RM550 IB inorganic black coating
- AZ Technology AZ3700 low emittance coating with 966 adhesive backing

MISSE-7B		Preflight	Postflight	$\Delta$	Environment
RM550IB	$\alpha$	0.974	0.974	-	3,200 ESH
	$\epsilon$	0.90	0.90	-	2.9E20 O atoms/cm <sup>2</sup>
AZ-3700	$\alpha$	0.28	0.26	-0.02	3,200 ESH
	$\epsilon$	0.31	0.38	+0.07	2.9E20 O atoms/cm <sup>2</sup>

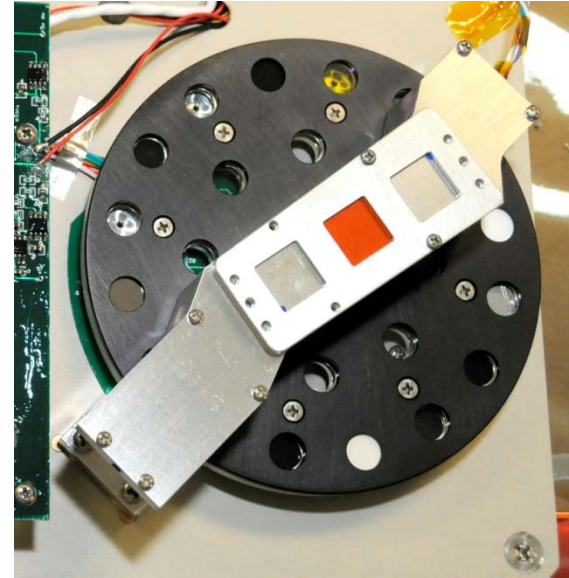
- **Anodized Aluminum Results**
  - **Black dyed sulfuric acid anodize used on carousels**

MISSE-7B		Preflight	Postflight	$\Delta$	Environment
Ram carousel	$\alpha$	0.71	0.70	-0.01	4,500 ESH
	$\epsilon$	0.86	0.87	+0.01	4.2E21 O atoms/cm <sup>2</sup>
Wake carousel	$\alpha$	0.69	0.68	-0.01	3,200 ESH
	$\epsilon$	0.86	0.86	-	2.9E20 O atoms/cm <sup>2</sup>

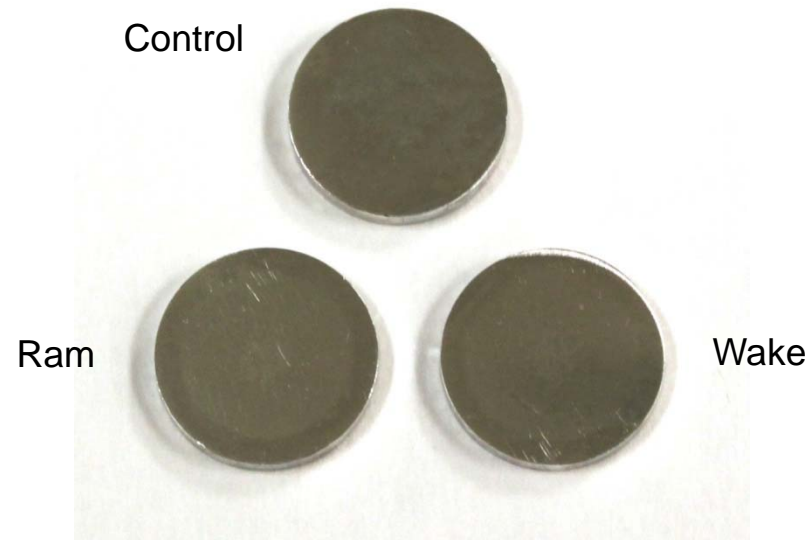
- Alodine 5700 chrome-free

Alodine 5700		Pre-exp	Post-exp	$\Delta$	Environment
Control	$\alpha$	0.21	0.21	-0.01	-
	$\epsilon$	0.03	0.03	-	-
MISSE-7B Ram	$\alpha$	0.21	0.16	-0.05	4,500 ESH
	$\epsilon$	0.03	0.03	-	4.2E21 O atoms/cm <sup>2</sup>
MISSE-7B Wake	$\alpha$	0.20	0.18	-0.02	3,200 ESH
	$\epsilon$	0.03	0.04	+0.01	2.9E20 O atoms/cm <sup>2</sup>

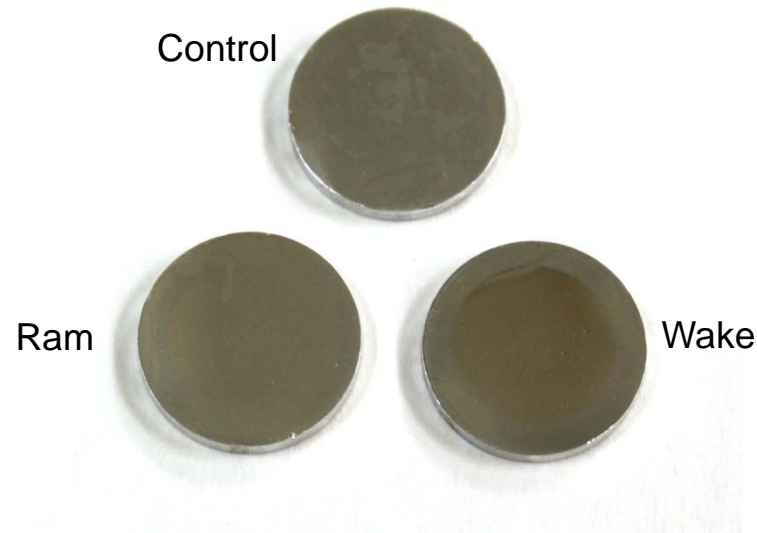
- Boegel chrome-free

Alodine 5700		Pre-exp	Post-exp	$\Delta$	Environment
Control	$\alpha$	0.18	0.18	-	-
	$\epsilon$	0.03	0.03	-	-
MISSE-7B Ram	$\alpha$	0.18	0.14	-0.04	4,500 ESH
	$\epsilon$	0.03	0.03	-	4.2E21 O atoms/cm <sup>2</sup>
MISSE-7B Wake	$\alpha$	0.18	0.22	+0.04	3,200 ESH
	$\epsilon$	0.03	0.03	+0.01	2.9E20 O atoms/cm <sup>2</sup>

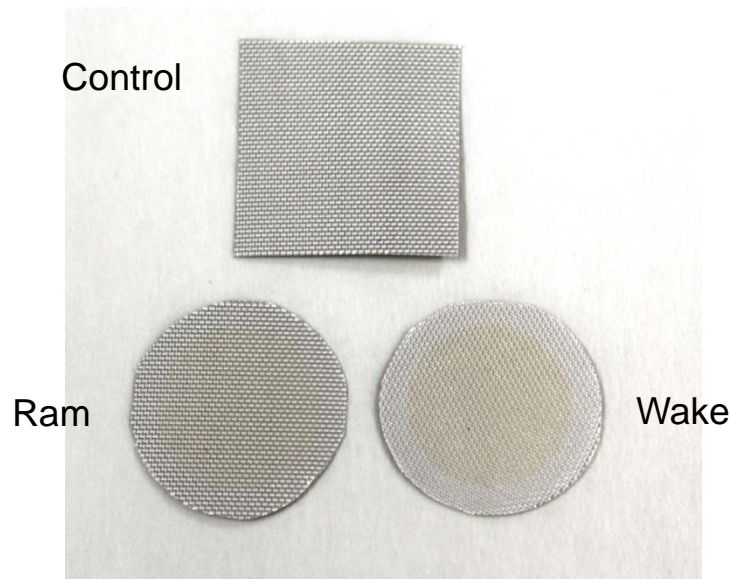
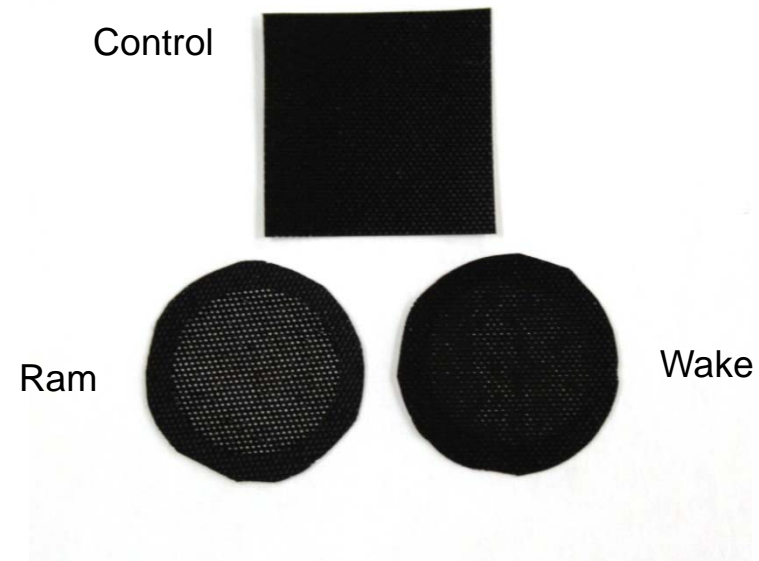
## Beta Cloth

- Chemglas 500F is the same glass weave and Teflon as used in ISS insulation blankets
- Proprietary black coating used instead of aluminization for light blocking layer
- Samples flown on both ram and wake, white side and black side

Pre-exp	Post-exp	$\Delta$	Environment
White side ram facing	$\alpha$	0.42	0.43	+0.01	4,500 ESH
	$\epsilon$	0.89	0.89	-	4.2E21 O atoms/cm <sup>2</sup>
White side wake facing	$\alpha$	0.41	0.44	+0.03	3,200 ESH
	$\epsilon$	0.89	0.88	-0.01	2.9E20 O atoms/cm <sup>2</sup>
Black side ram facing	$\alpha$	0.97	0.93	-0.04	4,500 ESH
	$\epsilon$	0.88	0.89	+0.01	4.2E21 O atoms/cm <sup>2</sup>
Black side wake facing	$\alpha$	0.97	0.96	-0.01	3,200 ESH
	$\epsilon$	0.88	0.88	-	2.9E20 O atoms/cm <sup>2</sup>

**White side beta cloth results approx. the same change as previous MISSEs with and without aluminization**

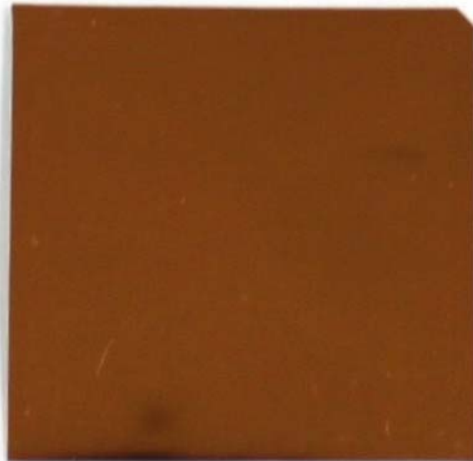
1500 ohms/sq

- Discussed with Multek/Sheldahl personnel why control samples degraded as well.
  - Could be microcracking due to handling
  - 1500 ohms/square sample would have thicker ITO layer
  - 2 – 3M ohms/square still considered static dissipative

- **Two different resistivities flown on wake side**
- **Negligible mass change for both samples**
- **Flight sample labeled 1500 ohms/square still measures 1570 – 1610 ohms/square post-flight**
- **Flight sample labeled 20K ohms/square now measures 2 – 3M ohms/square post-flight, as do the control samples.**
- **Original sheet materials that the control and flight samples were cut from still measure 1500 and 20K ohms/square, respectively**

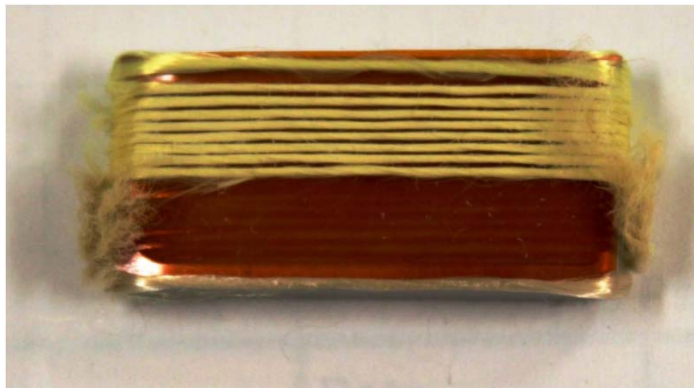
**Ram**

- Both yarn and cable materials flown on ram and wake sides
- Vectran yarn on ram side did not survive the exposure, but the cable only darkened, likely due to finish or sizing.
- Kapton flown underneath, can determine AO fluence to erode through Vectran (analysis continuing).

**Kevlar yarn on top, Vectran yarn on bottom**

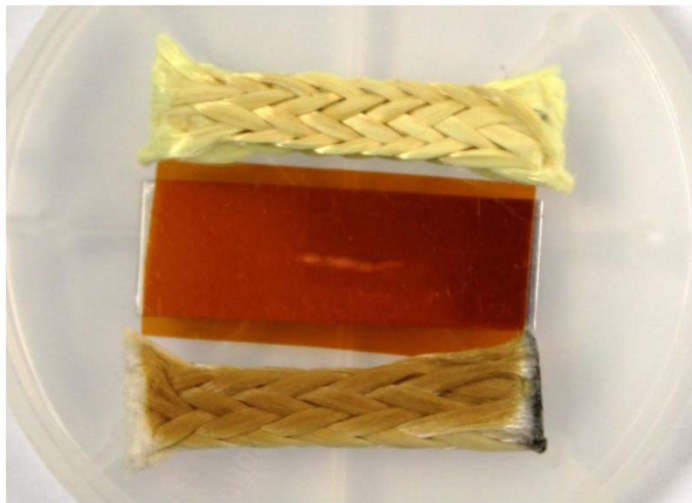
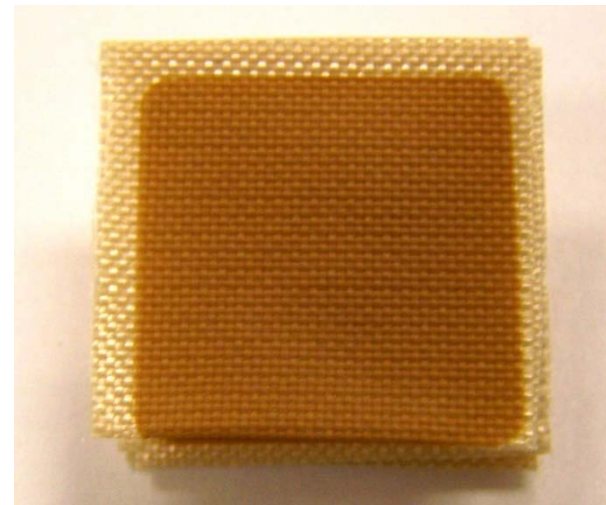
- Previously flown on MISSE-1, -2, and -4 were samples of Kevlar webbing, Kevlar felt, and Vectran HS with T150 finish, which is oil added to aid weaving.
- Vectran cables flown on MISSE-7B appears to have similar finish, which prevented AO erosion.

Left, top to bottom, ram-facing Kevlar cable, Kapton witness film, Vectran cable. Kevlar is eroded, Vectran is only UV-darkened. Compare to MISSE-1 Vectran on right.
